**Emergency Response Report**

Hydrogen Chloride - MGP, Atchison, Kansas

### EMERGENCY RESPONSE REPORT

### HYDROGEN CHLORIDE – MGP, ATCHISON, KANSAS

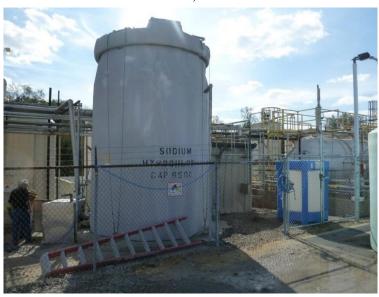
TETRA TECH PROJECT NO. X9025.14.0001.031	PHOTO DESCRIPTION	This photograph shows a 6,500-gallon aboveground storage tank (AST) containing sodium hypochlorite at the industrial wastewater pretreatment facility operated by MGP Ingredients, Inc. (MGP).	1
11,023.11.0001.031	CLIENT	U.S. Environmental Protection Agency (EPA) Region 7	Date
Direction: South	PHOTO SOURCE	P. Doherty (EPA)	10/21/16

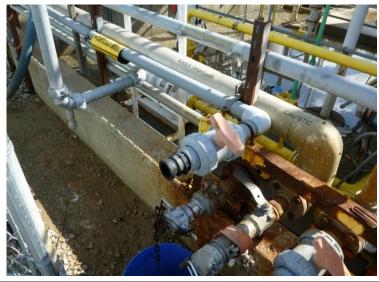
TETRA TECH PROJECT NO. X9025.14.0001.031	PHOTO DESCRIPTION	This photograph shows the pipe manifold where a hose from a tanker truck containing sulfuric acid was inadvertently connected to a sodium hypochlorite receiving line leading to the AST. The pipes are clearly labeled for the product that they are intended to transfer to the holding tanks.	2
	CLIENT	EPA Region 7	Date
Direction: Southeast	PHOTO SOURCE	P. Doherty (EPA)	10/21/16

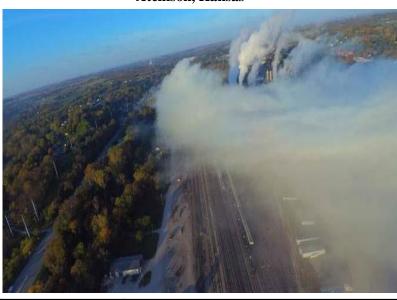
PHOTO DESCRIPTION	when sulfuric acid from the tanker truck was inadvertently transferred to the sodium hypochlorite AST.	
CLIENT	EPA Region 7	Date
PHOTO SOURCE	KSHB	10/21/16

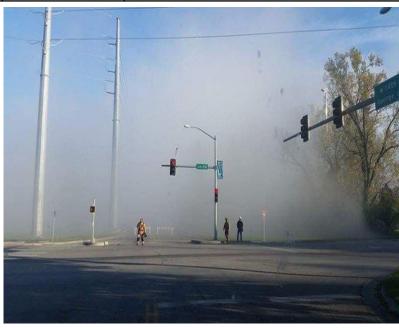
PHOTO DESCRIPTION	This photograph shows the chemical fog that covered much of downtown Atchison and spread approximately 10 miles north.	4
CLIENT	EPA Region 7	Date
PHOTO SOURCE	KCTV5	10/21/16

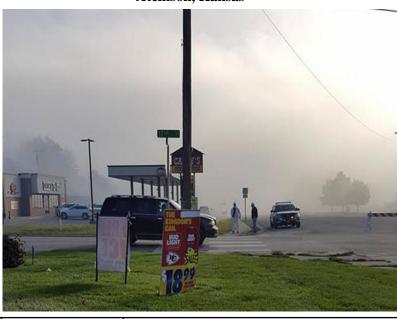
TETRA TECH PROJECT NO. X9025.14.0001.031	PHOTO DESCRIPTION	This photograph shows the chemical fog at the Casey's General Store at the intersection of Main Street and N. 17 <sup>th</sup> Street in Atchison. Residents were advised to stay indoors, keep windows closed, and turn heating and cooling systems off.	5
	CLIENT	EPA Region 7	Date
Direction: East	PHOTO SOURCE	One America News	10/21/16

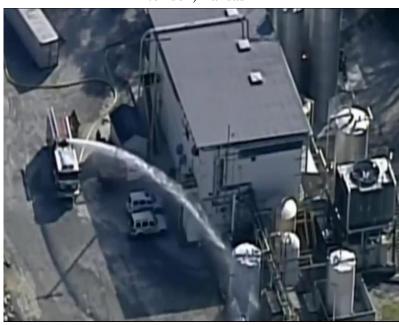
TETRA TECH PROJECT NO.	PHOTO DESCRIPTION	This photograph shows firefighters spraying water to suppress the airborne release. The plume began to dissipate within about an hour after the release occurred.	7
X9025.14.0001.031	CLIENT	EPA Region 7	Date
Direction: East	PHOTO SOURCE	NBC News	10/21/16

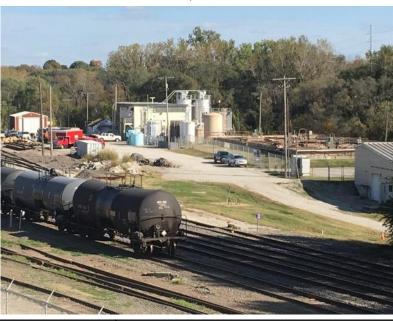
TETRA TECH PROJECT NO.	PHOTO DESCRIPTION	This photograph was taken from air monitoring location MR6 and shows the MGP industrial wastewater pretreatment facility south of the railroad tracks.	11
X9025.14.0001.031	CLIENT	EPA Region 7	Date
Direction: Southeast	PHOTO SOURCE	N. Wiederholt (START)	10/21/16

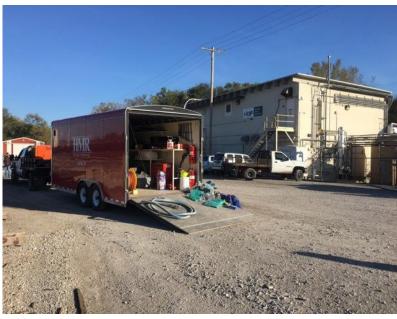
This photograph shows the equipment trailer for the	
TETRA TECH	PHOTO DESCRIPTION	hazardous materials (hazmat) response team that arrived on site to assist with chemical transfer from the 6,500-gallon	15
PROJECT NO. X9025.14.0001.031	DESCRIPTION	sodium hypochlorite AST.	
A9023.14.0001.031	CLIENT	EPA Region 7	Date
Direction: Southeast	PHOTO SOURCE	N. Wiederholt (START)	10/21/16

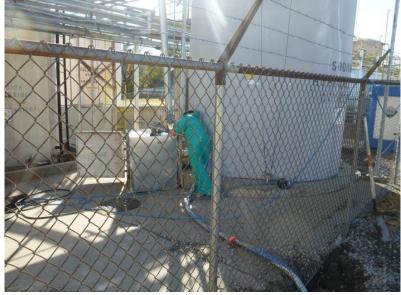
TETRA TECH PROJECT NO.	PHOTO DESCRIPTION	This photograph shows a hazmat employee connecting a hose to the sodium hypochlorite tank.	16
X9025.14.0001.031	CLIENT	EPA Region 7	Date
Direction: Southwest	PHOTO SOURCE	P. Doherty (EPA)	10/21/16

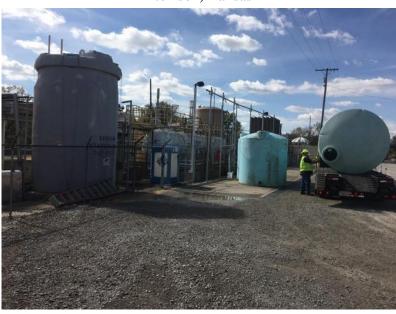
TETRA TECH PROJECT NO.	PHOTO DESCRIPTION	This photograph shows a hazmat employee unloading a large portable polyethylene tank that was used to contain the contaminated sodium hypochlorite solution.	17
X9025.14.0001.031	CLIENT	EPA Region 7	Date
Direction: Southwest	PHOTO SOURCE	N. Wiederholt (START)	10/21/16

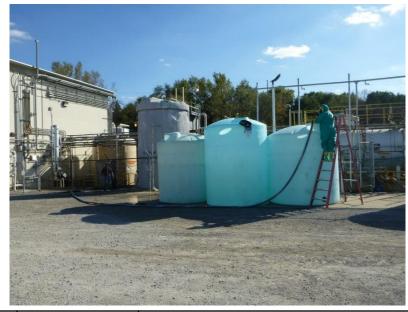
TETRA TECH PROJECT NO.	PHOTO DESCRIPTION	This photograph shows the transfer of contents from the 6,500-gallon sodium hypochlorite tank to portable tanks for characterization and disposal.	18
X9025.14.0001.031	CLIENT	EPA Region 7	Date
Direction: Southeast	PHOTO SOURCE	P. Doherty (EPA)	10/21/16
